# Restoration of Soldier Spring: an isolated habitat for native Apache trout

## Abstract

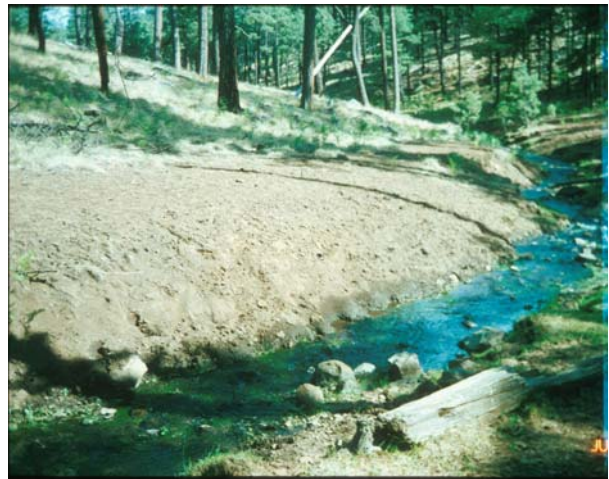
**Figure 1:** View downstream from the spring, June 1996, prior to treatment, revealing the bare streambanks that were common along reach.

Field surveys from 1995 to 1997 revealed that the channel was actively downcutting (Fig. 1). The streambanks lacked native wetland plants and were trampled by ungulates (horses, cattle, and elk). We found remnants of log structures, demonstrating an earlier, unsuccessful attempt to enhance or stabilize the stream. New restoration efforts began in 1998 with support from a number of tribal, federal, and school organizations. By 2004 (Fig. 2), we are able to evaluate the numerous gains that have been achieved at this restoration site.

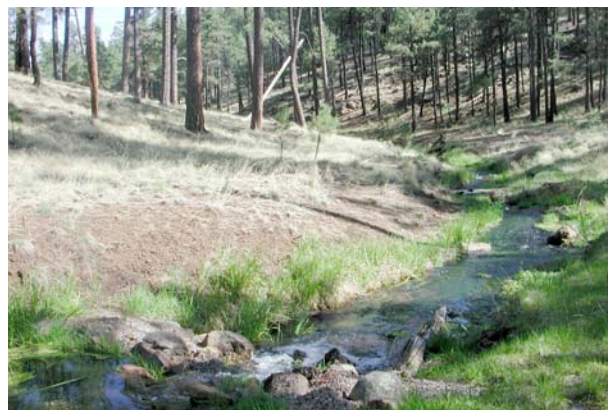
**Figure 2:** View downstream from the spring, May 2004, six years after the initial treatment, showing one of the riffle formations and the increase in streamside vegetation.

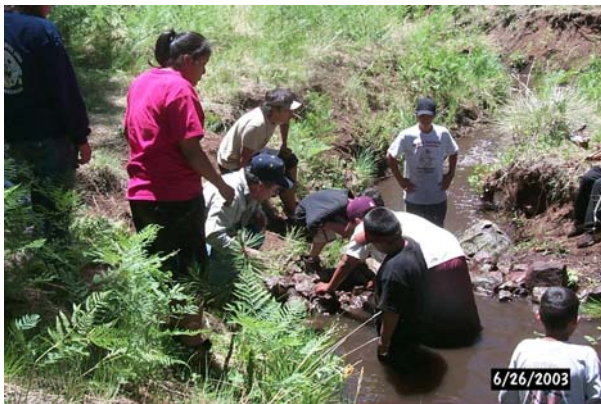
**Figure 3:** Participants at the White Mountain Apache Tribe’s summer youth camp helped to build riffle formations by hand using rocks from adjacent side-slopes.

To arrest the downcutting, we needed to include a structural intervention as part of the comprehensive treatment of the site. Rather than relying on wood as in earlier efforts, we used rock and gravel “riffle formations” that recreate the natural grade control features of a step-pool system (Medina & Long 2004). These formations were built by hand using rocks from the adjacent slopes (Fig. 3) and gravels imported to the site using wheelbarrows. In addition to providing grade control, these rock riffle formations rearmor the streambed to improve substrate quality for the trout. We also recognized the need for in-stream and shoreline herbaceous vegetation to stabilize banks, to provide habitat for aquatic organisms, and to knit the grade control features into the banks. Therefore, we integrated sedge transplants with our riffle formations to stimulate recovery of stabilizing vegetation. Because ungulate grazing was reducing streambank stability and vegetation development, we excluded ungulates by erecting a large, solar-powered electric fence around the site.

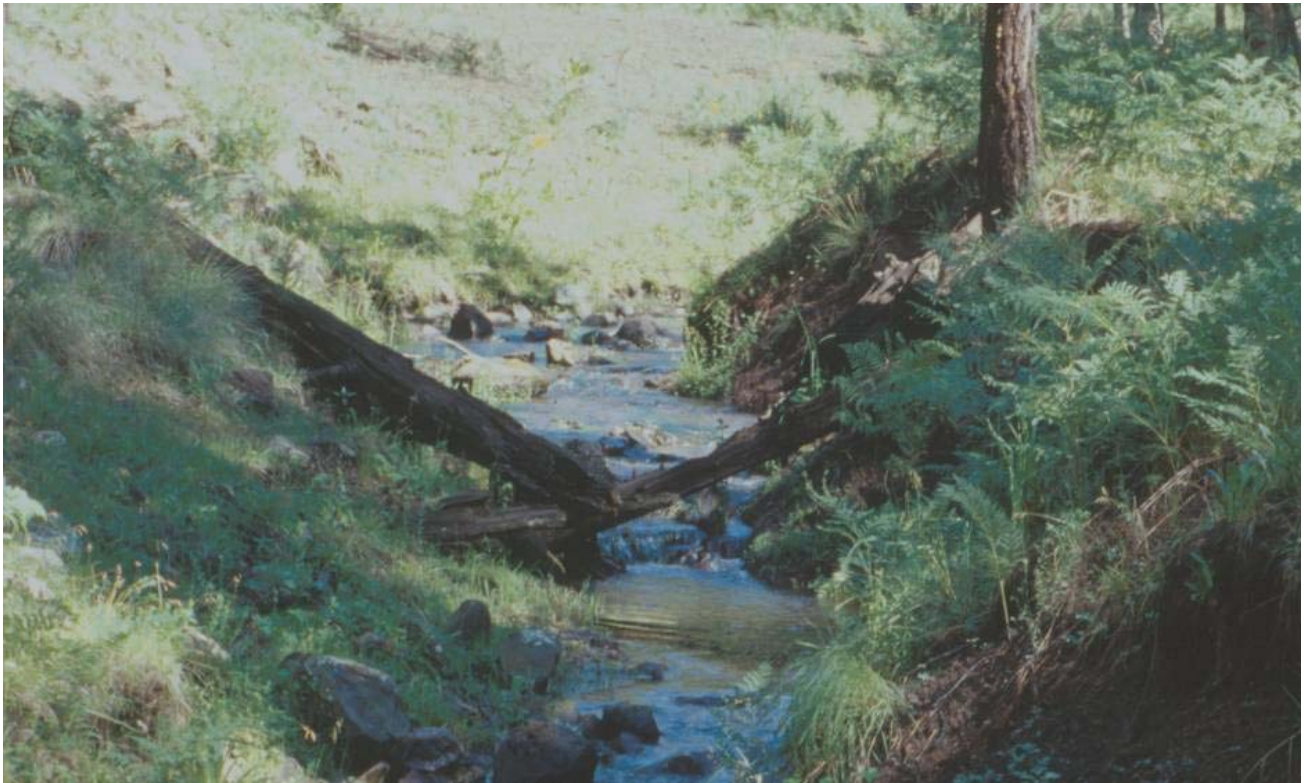
**Figure 4:** View of Soldier Creek before placement of riffle formation, June 1998. The logs in the channel were remnants of a failed grade control structure dating to the 1980s.

Figures 4 and 5 depict a typical incised reach before and after treatment with a riffle formation. Due to the protective fencing, transplanting, and raising of the water level along the stream, streamside vegetation growth was vigorous. Transplanted sedges bound to the streambed and banks within the first year, and these plants have begun to climb higher along the edges of the banks (Fig. 2). The formations have become interwoven with aquatic vegetation, including extensive beds of water buttercup (*Ranunculus aquatilis*), manna grass (*Glyceria* spp.), and sedges (*Carex* spp.). Dense growth of the aquatic plants in the channel has concentrated flow (Fig. 6), thereby helping to cleanse fines from the gravel substrates.

The treatments achieved the primary objective of arresting channel degradation and reforming riffle features. The riffle formations mimic naturally formed gravel bars, which serve to transform a high energy-laden flow into a more tranquil one through changes in bed forms, bed armoring and longitudinal profile (Heede 1986). Log steps and gravel bars both provide grade control in natural streams, but log steps are less flexible structures (Heede 1985). For example, logs often induce lateral erosion because small streams cannot reposition them efficiently, log steps can destabilize the channel once they rot out, and logs do not provide a rooting medium for aquatic plants until they are so rotted that they no longer perform a structural function (Fig. 4 shows a typical failed log structure).

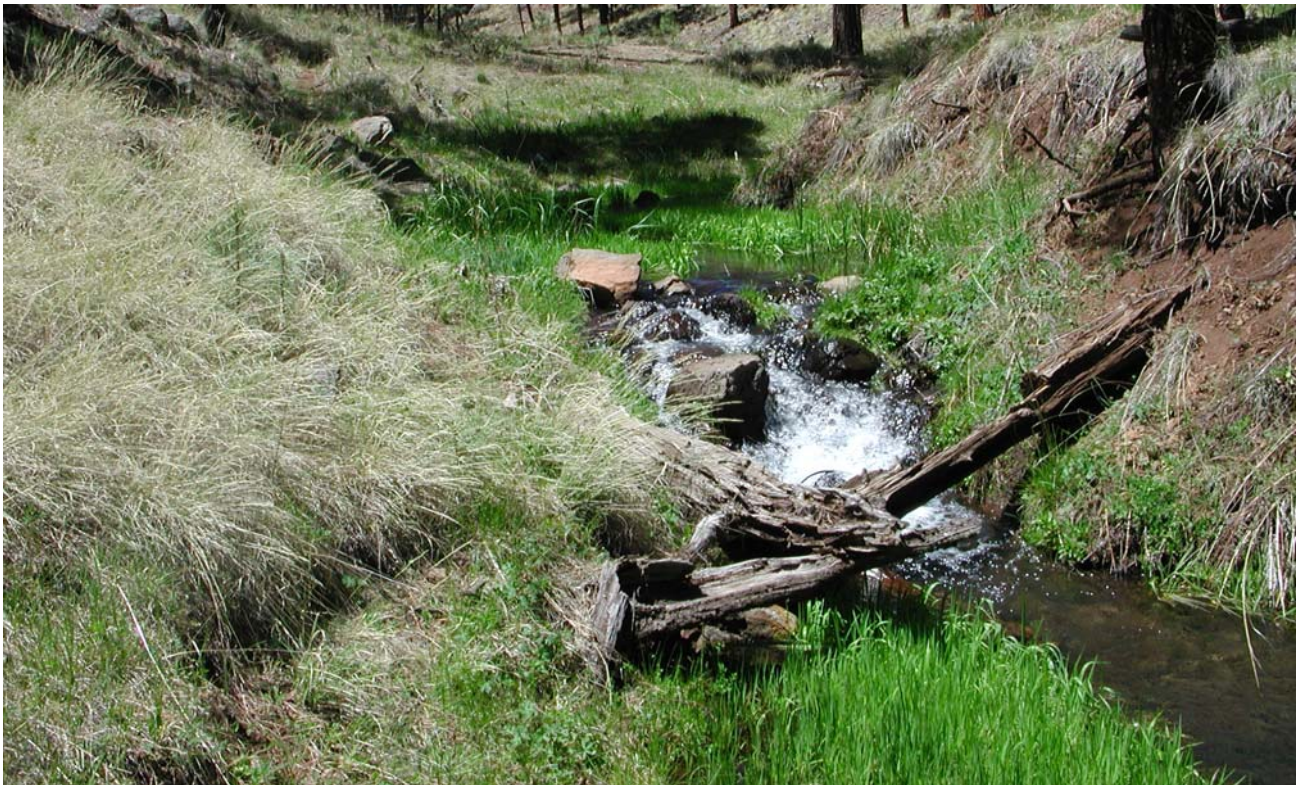
**Figure 5:** View of Soldier Creek after treatment, May 2004. The photo reveals growth of aquatic grasses above, below, and along the formation.

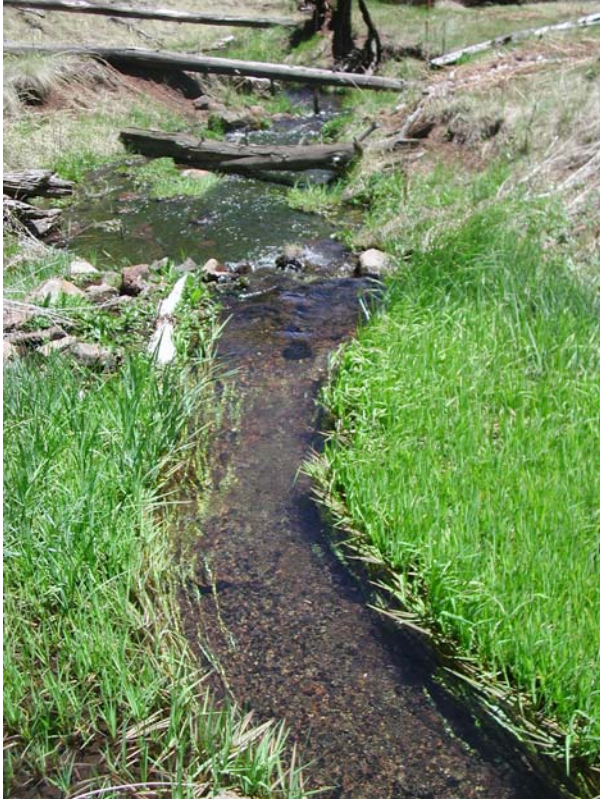
**Figure 6:** View downstream at a riffle formation, showing the dense growth of mannagrass (right) and Nebraska sedge (left), which confines flows and in turn keeps the gravel substrate clean (center).
